BK 89 PG 22**CORNER RECORD**

CR 9250City of SAN LEANDROCounty of ALAMEDA

Brief Legal Description INTERNATIONAL BLVD. AND 96TH AVE.

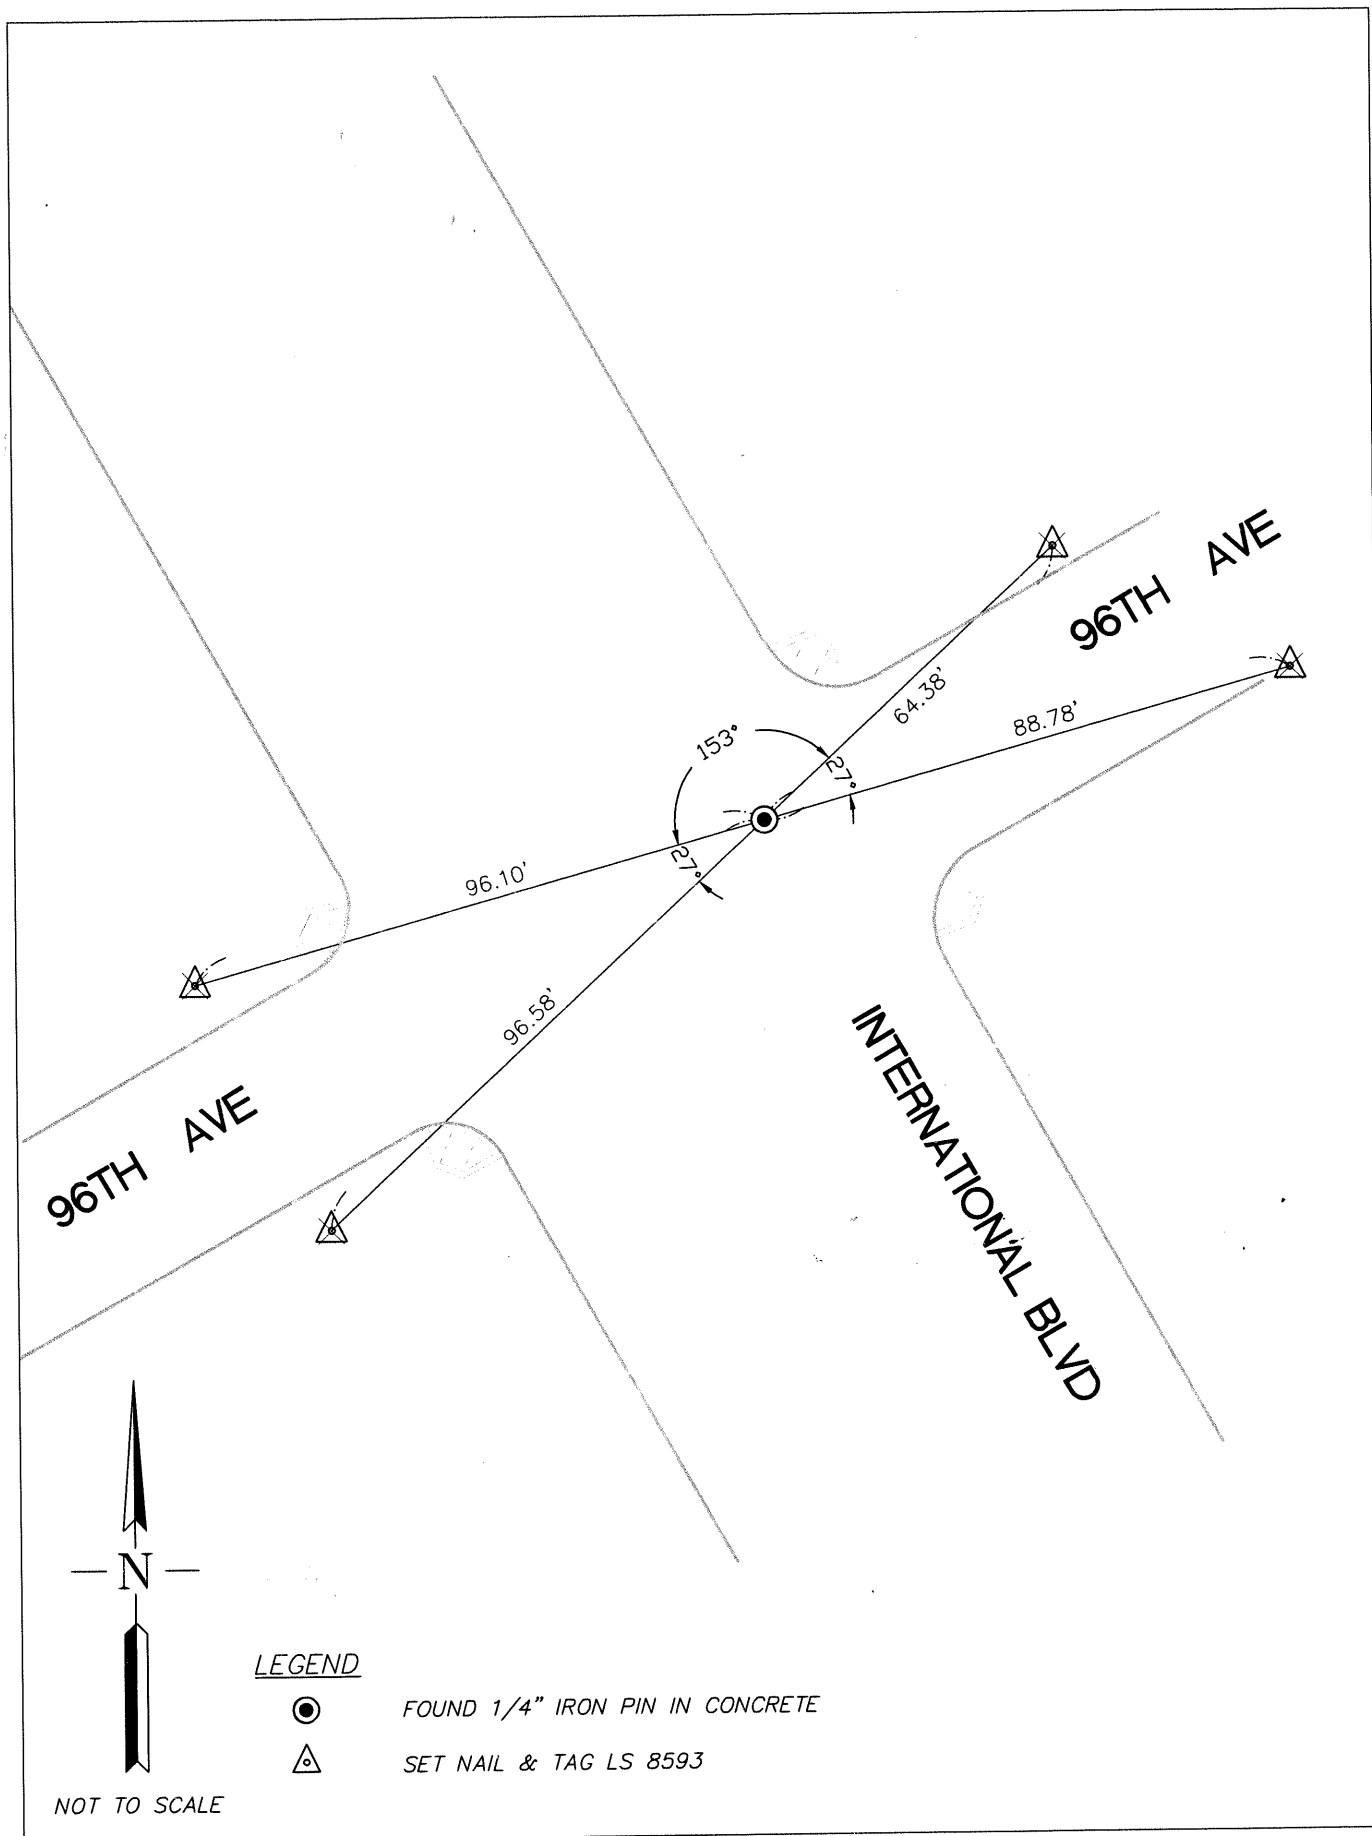
SET NAIL AND TAG, STAMPED LS 8593 AS REFERENCE POINTS TO BE USED TO RESET MONUMENT SHOULD IT
BE DISTURBED DURING CONSTRUCTION ACTIVITIES.
SEE SHEET 2 FOR GRAPHIC**SURVEYOR'S STATEMENT**
